CALSPAN ON-SITE INADVERTENT AIR BAG DEPLOYMENT INVESTIGATION

CALSPAN CASE NO. 92-8

VEHICLE - 1990 PLYMOUTH ACCLAIM

LOCATION - [REDACTED], GA

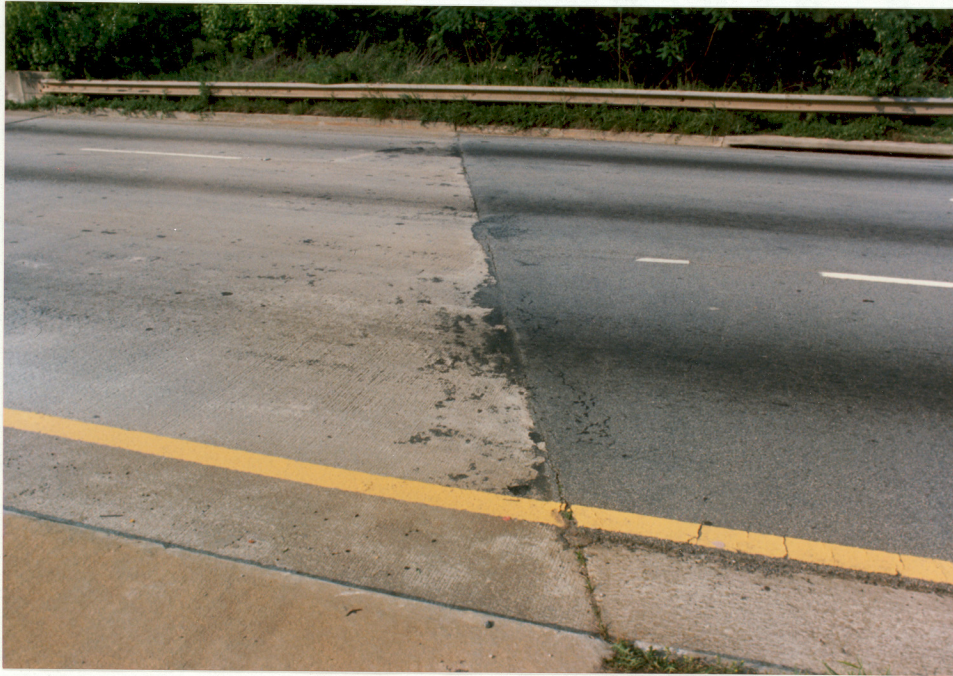
Transition Point From The Asphalt Road Surface To The Concrete Bridge Surface.

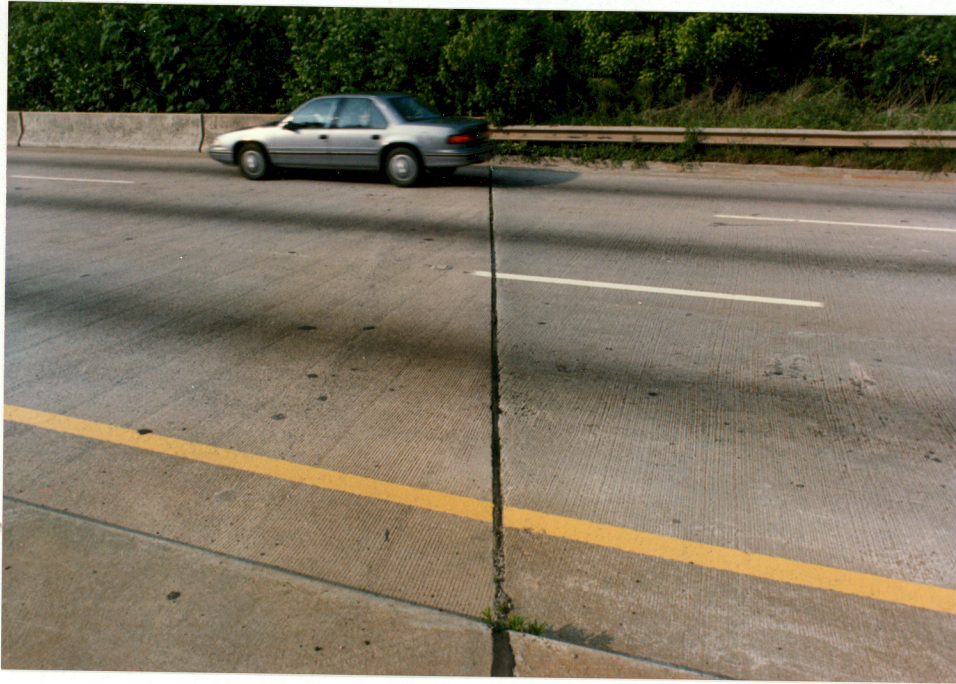
2" Wide Pour Joint Near Beginning Of Bridge.

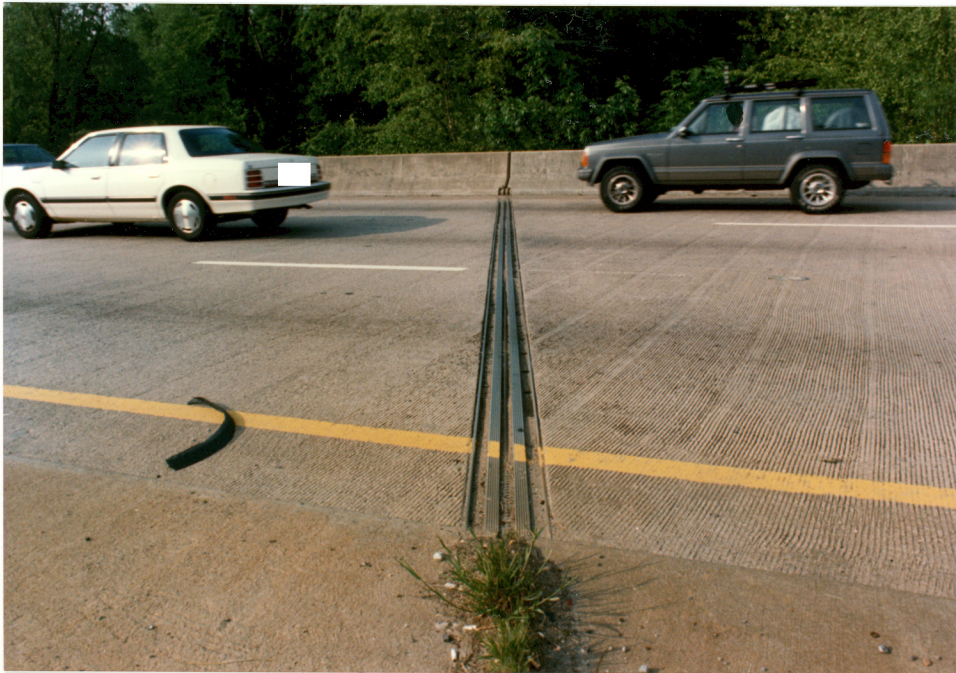
Expansion Joint At The Mid Bridge Area.

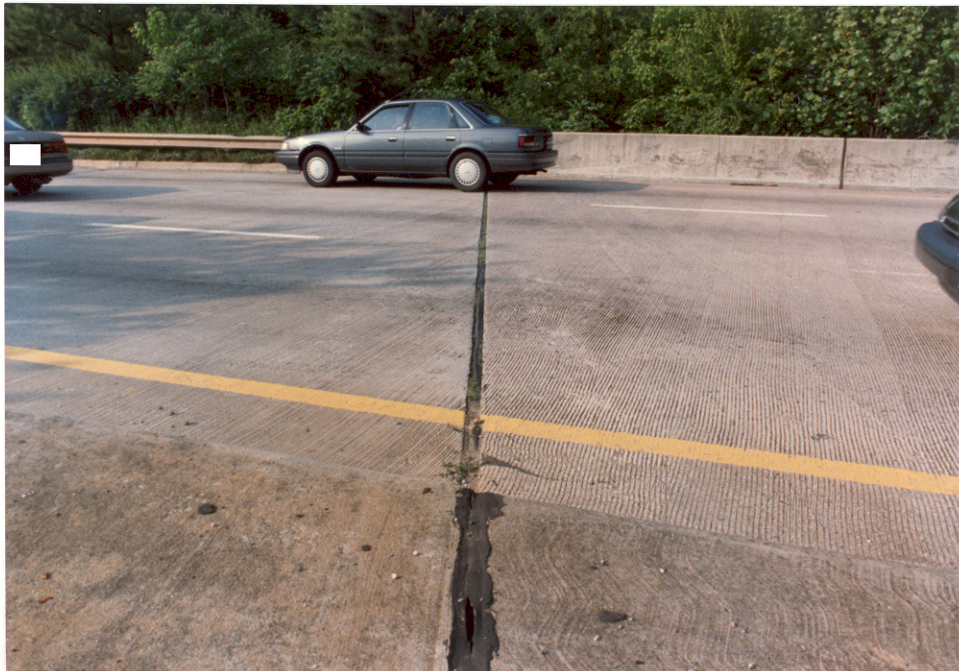
2" Wide Pour Joint In Concrete Surface Located 30' From End of Bridge.

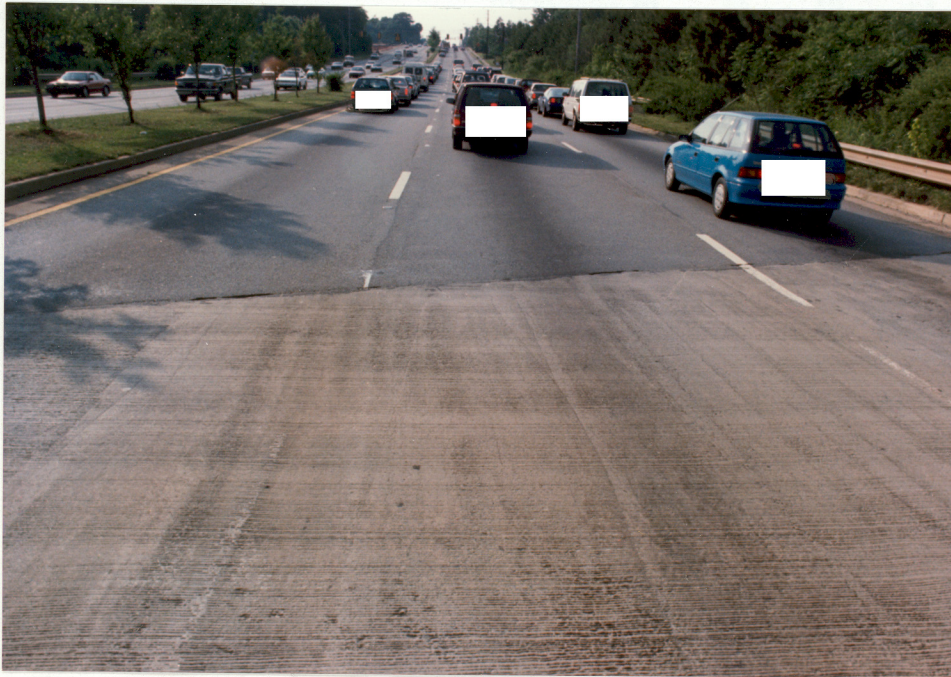
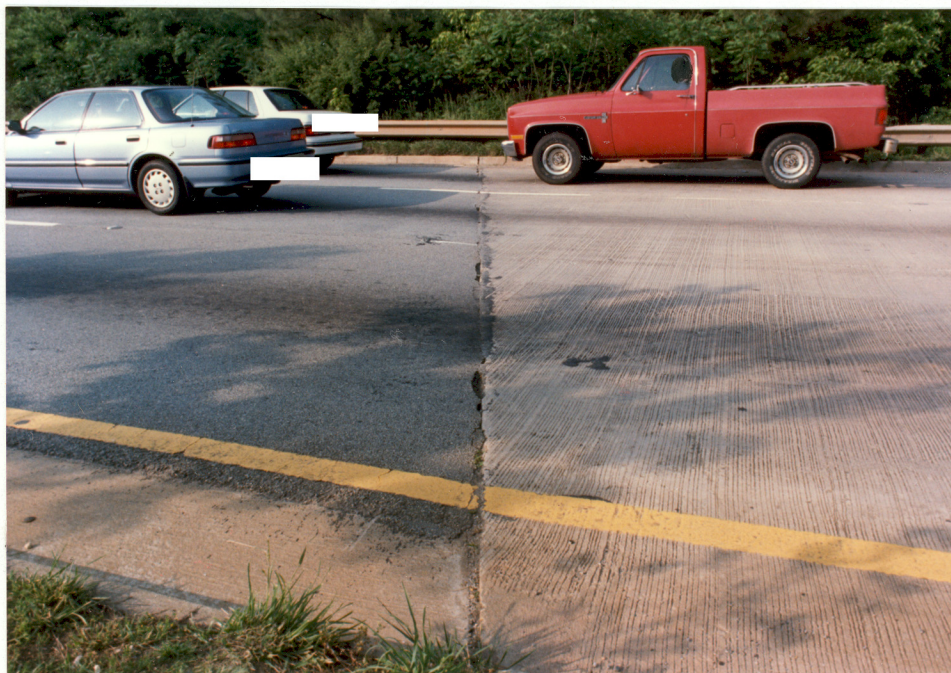
Transition Point From The Concrete Bridge Surface To The Asphalt Road Surface.

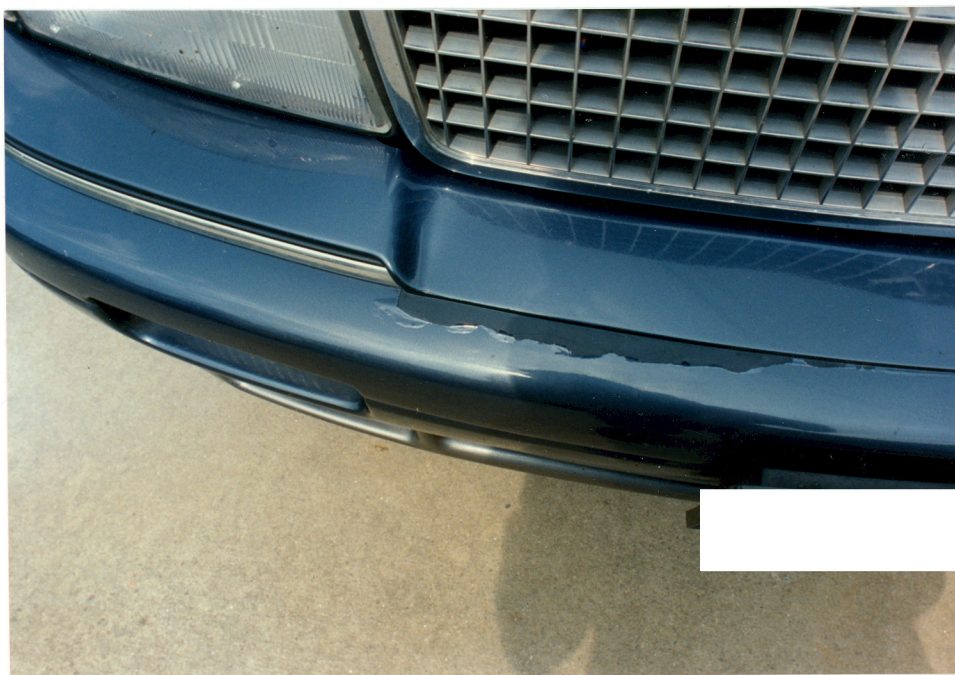
Paint Peeling From The Top Surface (Horizontal) Of The Right Front Bumper Facia.

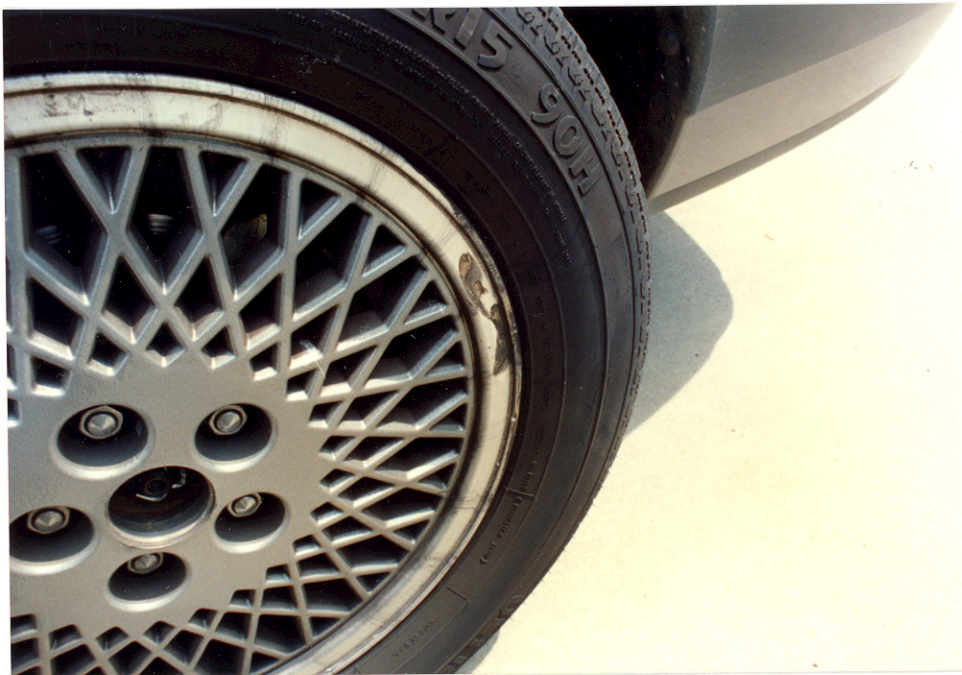
Dealer Documented Damage To The Right Front Wheel.

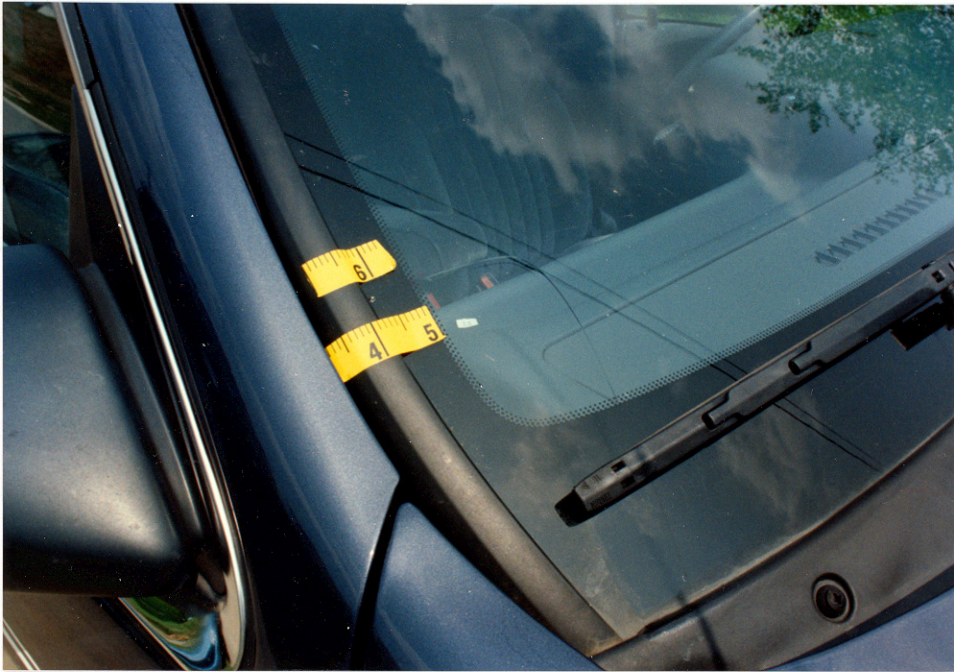
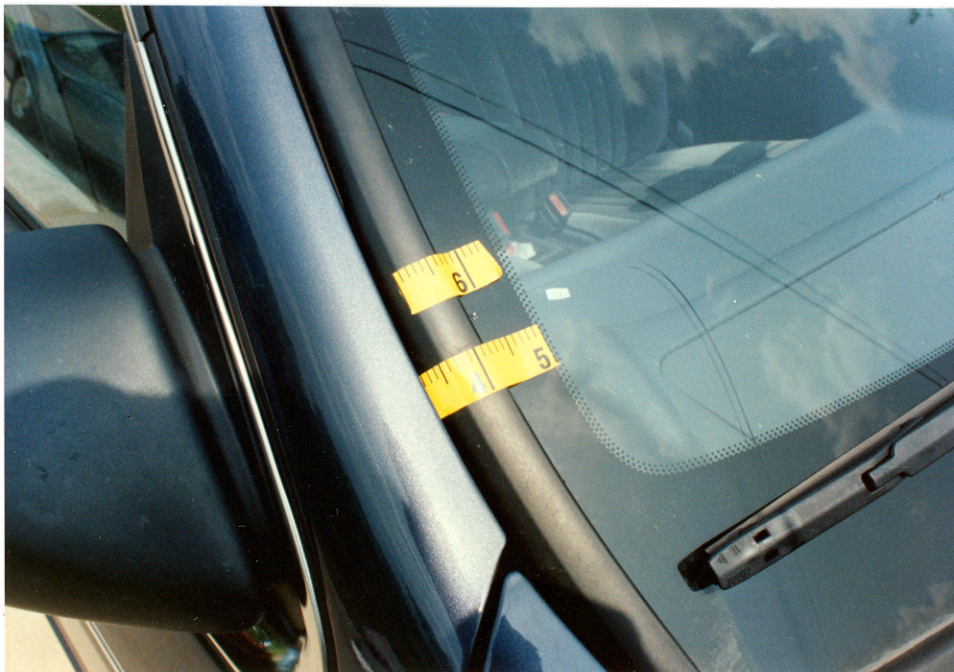
Crack To The Outer Pane Of The Windshield At The Lower Right Corner,
Crack Appears To Originate From A Stone Chip Located 0.125" Inboard
Of The Right A-Pillar.

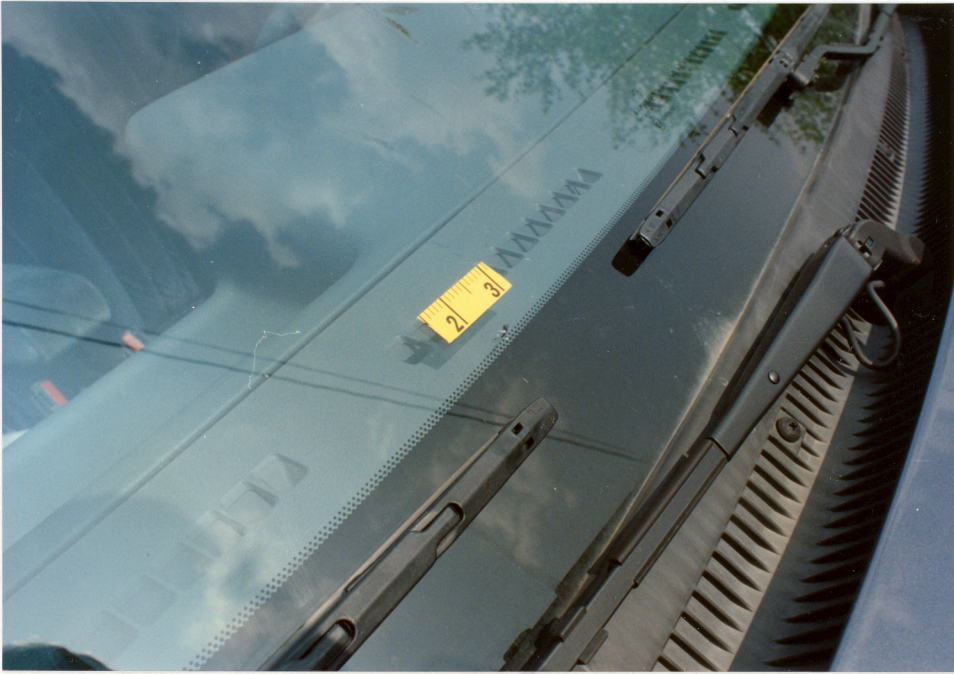
Another Stone Chip Near The Lower Center Portion Of The Windshield.

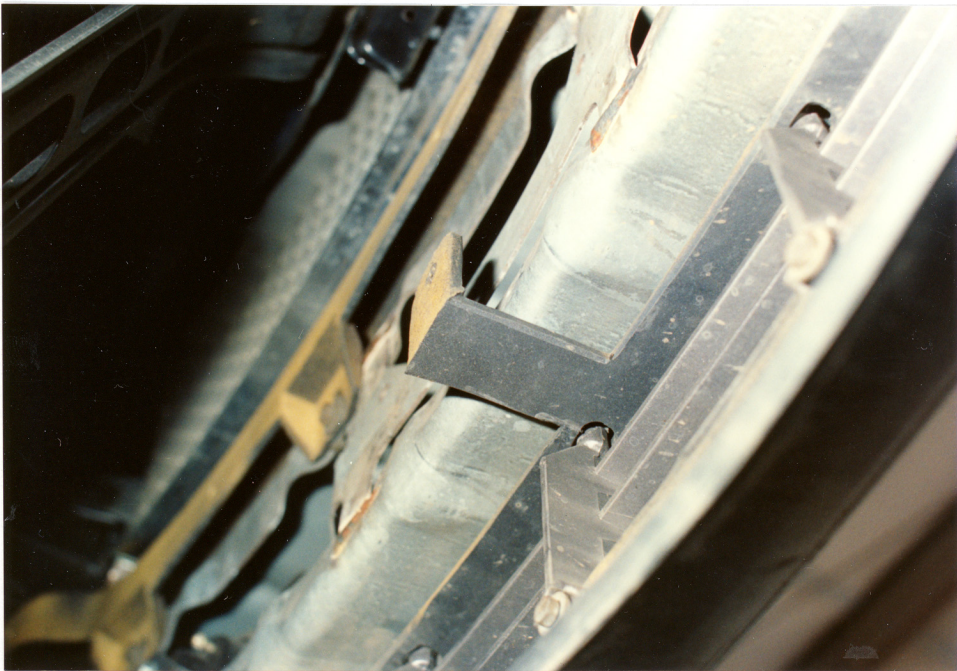
Center Support Bracket For The Lower Bumper Facia
(Push Plug Missing, Bracket Not Attached To Bumper Rebar).

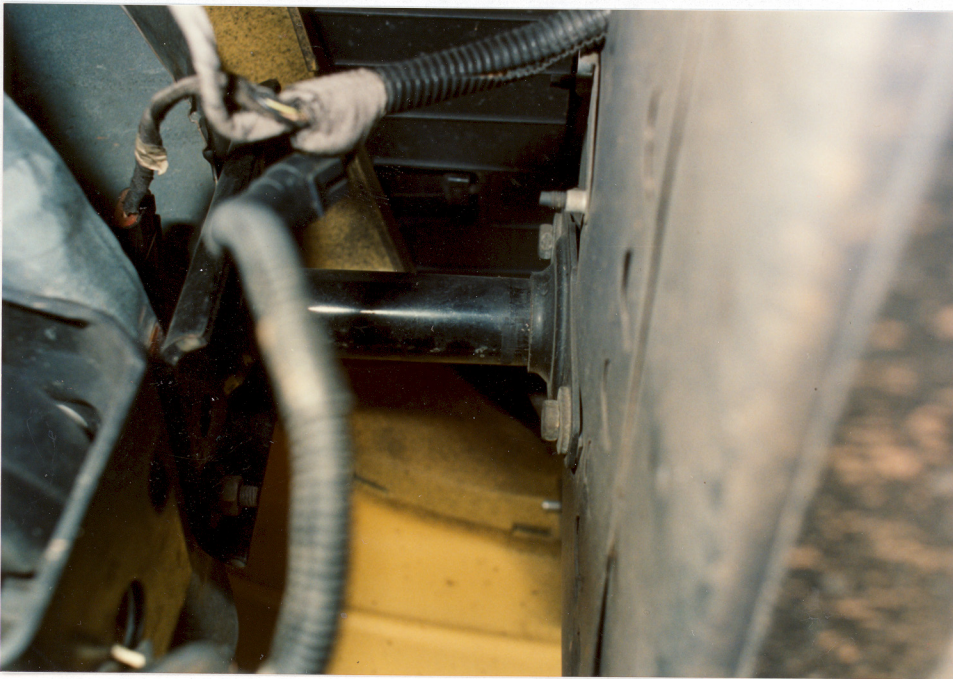
Right Front Bumper Energy Absorbing Device (EAD); 7/16" Of Compression And Return.

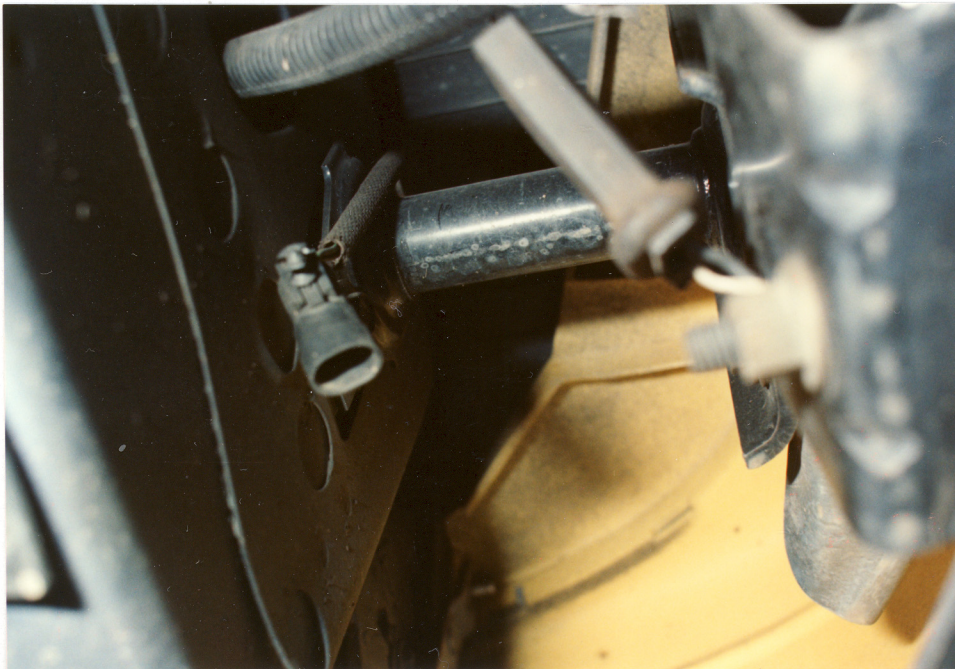
Left Front Bumper EAD; 1/4" Of Compression And Return.

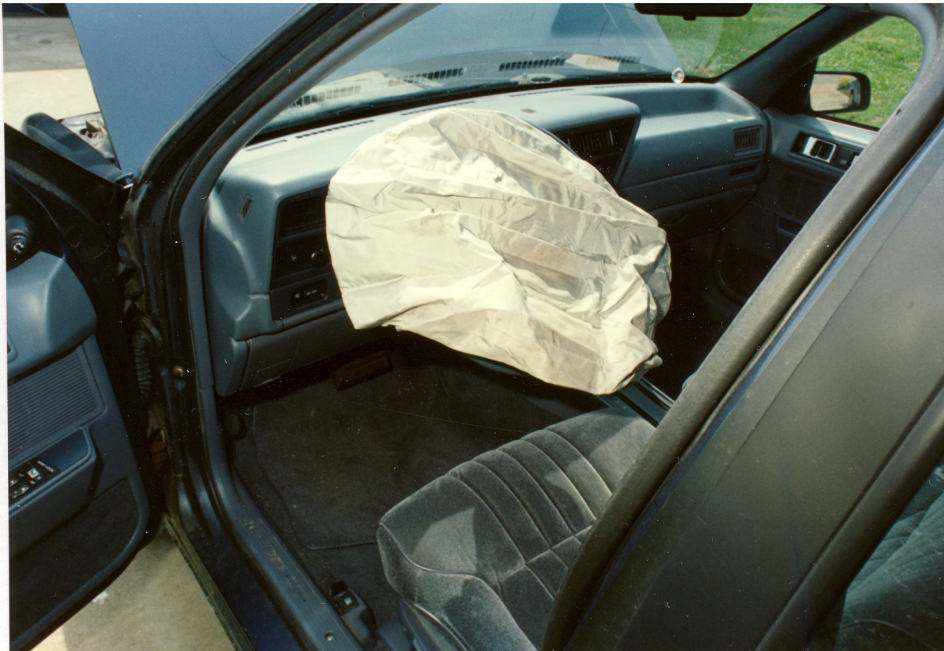
The air bag deployed properly from the module assembly. The module cover tore open in a H-configuration at the designated tear points. The bag was not damaged and was found neatly folded into the module cover. The air bag was identified by the following number sequence:

Deployed Driver's Air Bag.

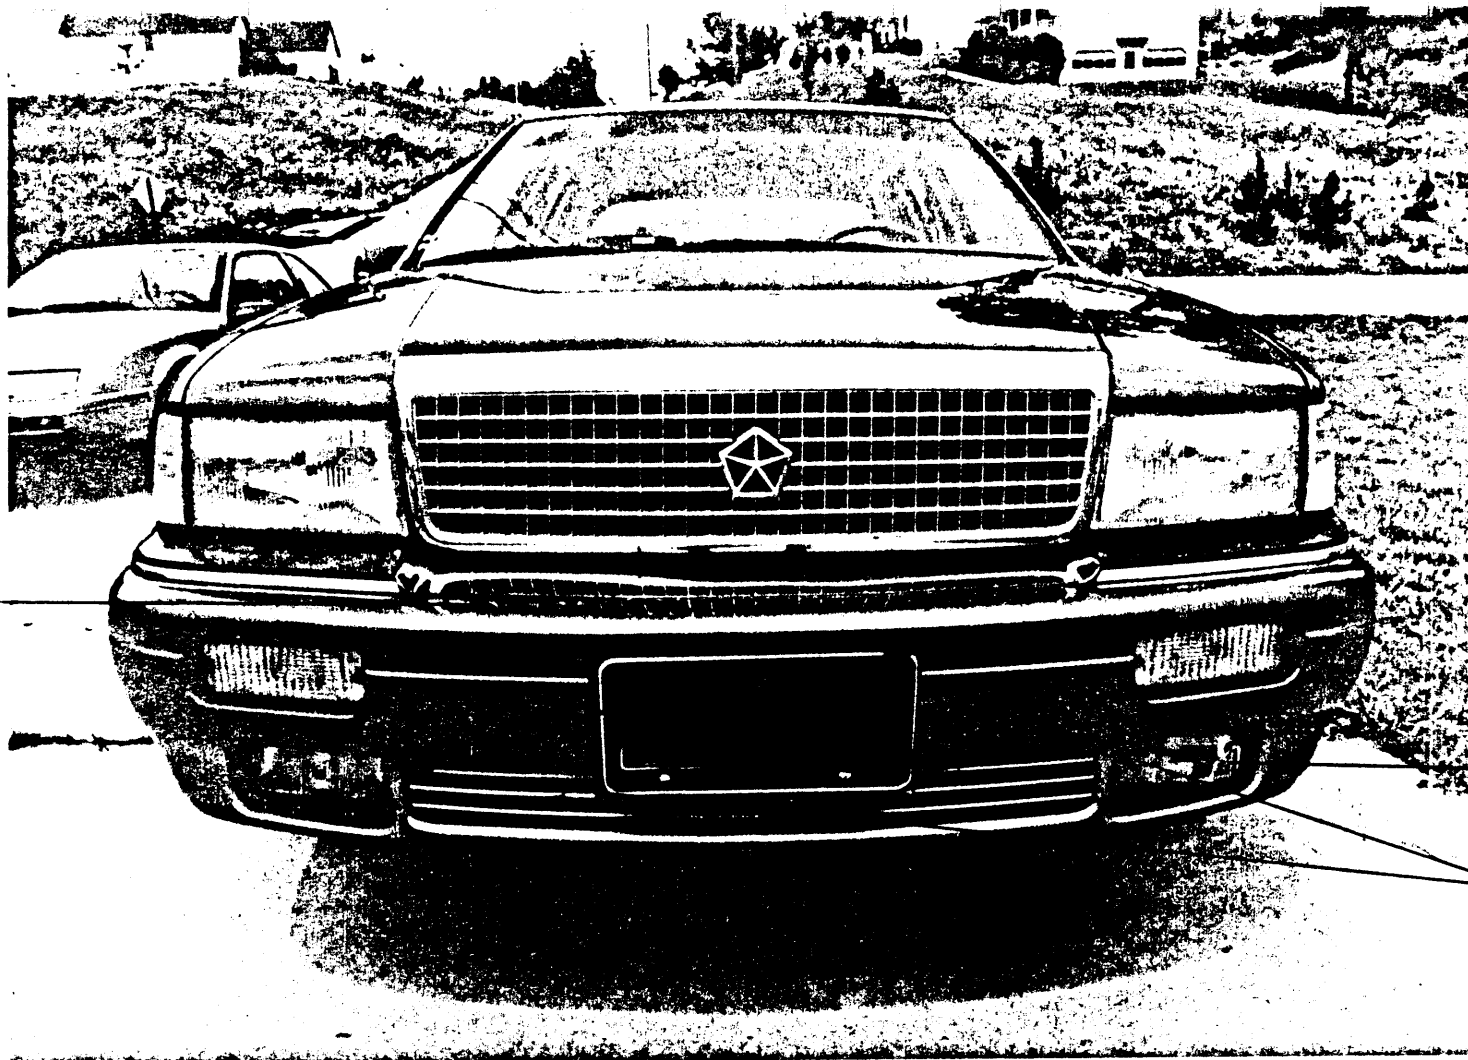
Paint peeling
from top of
bumper facia

Driving lamp lens
cracked

Paint chipped
